# Fourth and Osuna Village Center Conditions Analysis and Designation Report

February 2, 2007

Prepared by  
Sites Southwest Ltd. Co.

for the Village of Los Ranchos de Albuquerque, New Mexico

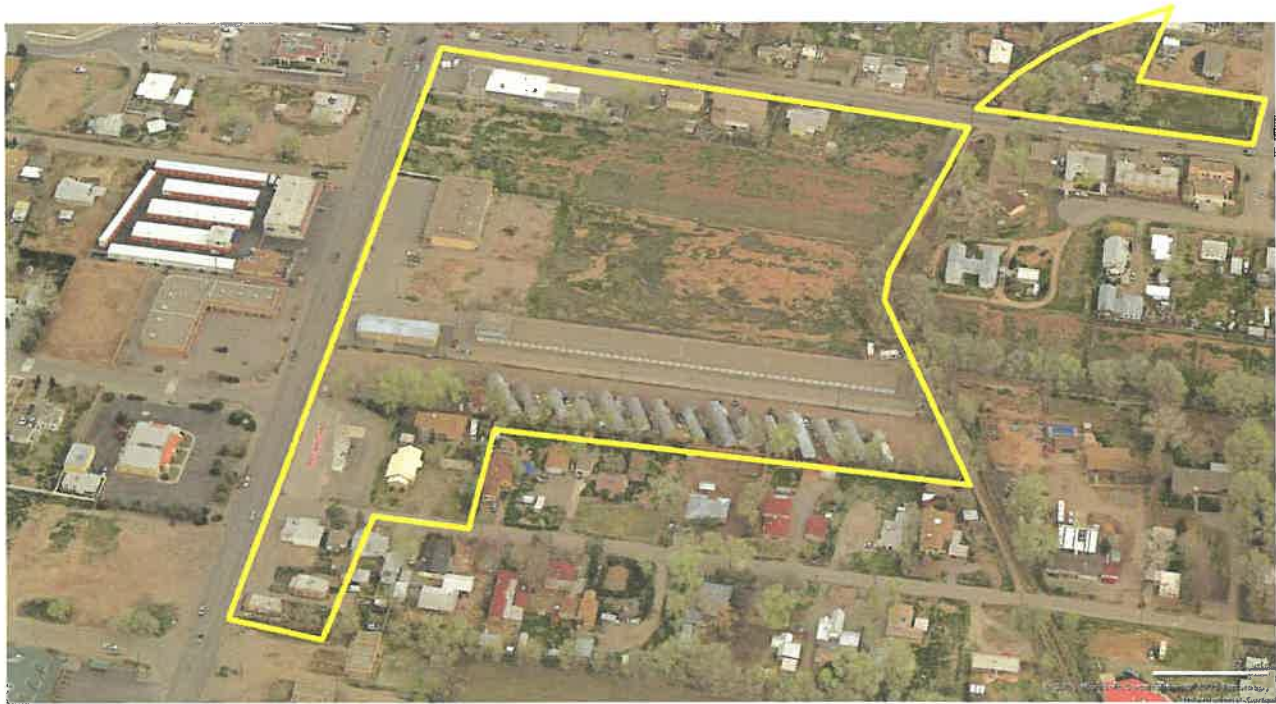
**Figure 4. Study Area**

The photo in Figure 4 shows the locations of development within the study area.

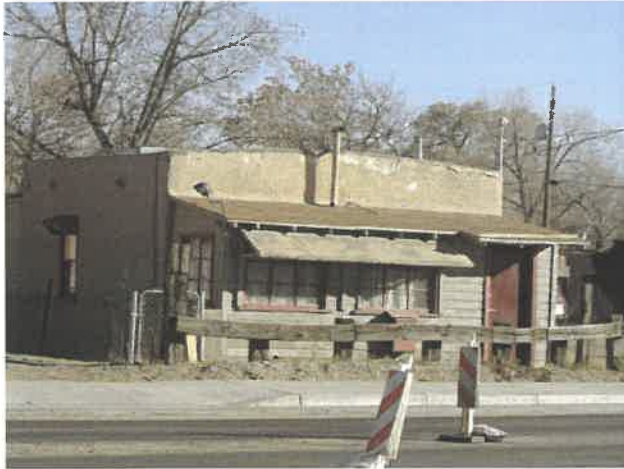
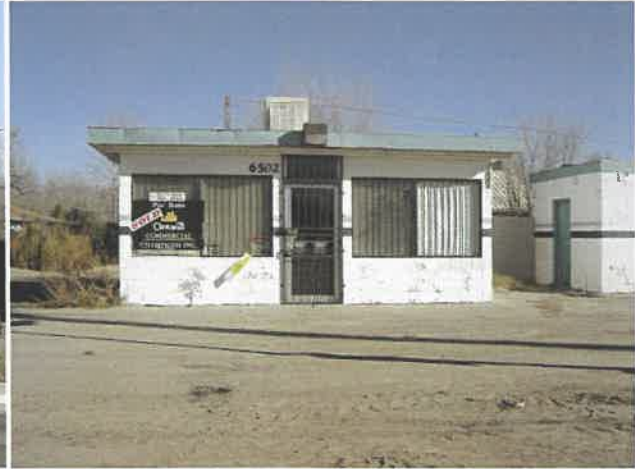
There are several deteriorated or deteriorating structures in the study area. These include structures on Parcels 15, 18 and 19. In addition, the condition of the mobile home park (Parcel 14) is poor. The mobile home park has been the subject of frequent and numerous code violations and notices since 1999. These violations include illegal structures, building code violations and fire code violations, principally associated with construction of substandard additions to existing mobile homes. In addition, there have been a large number of responses to this address by the Bernalillo County Sheriff’s Department, Los Ranchos Animal Control, and the Los Ranchos Fire and Rescue Department.

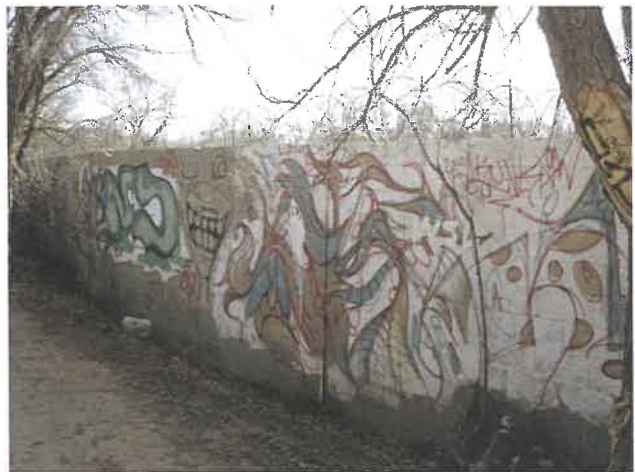
Weeds and litter are the most common problems on vacant properties.

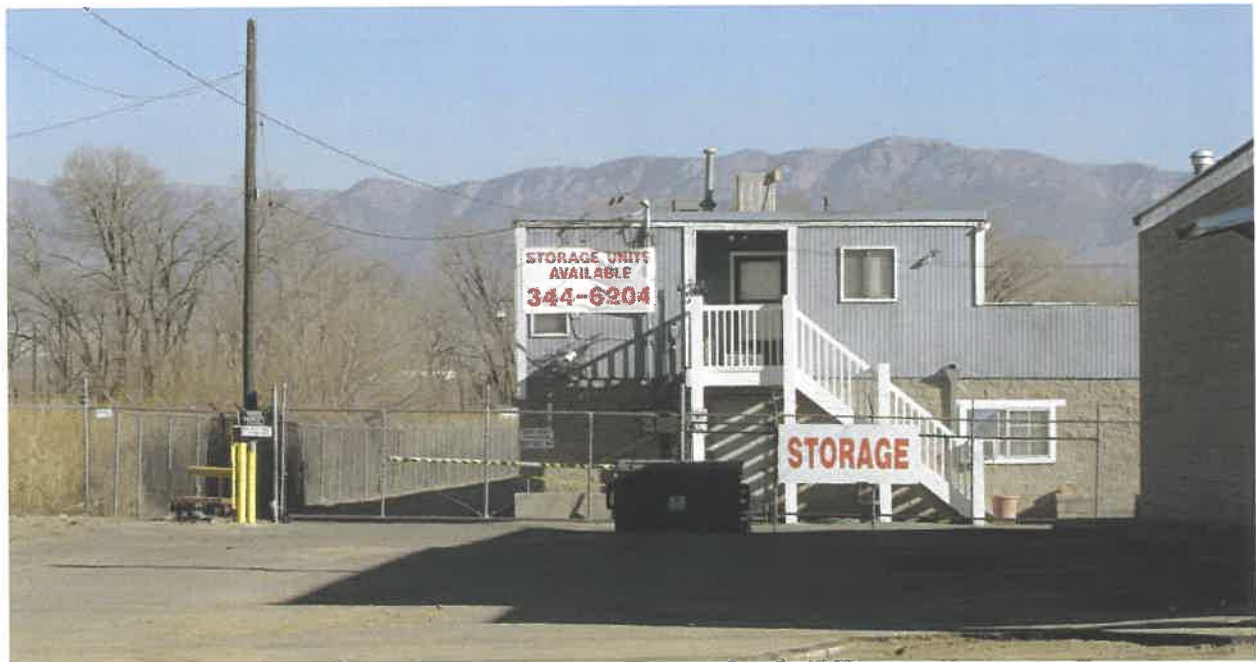
**Property #12. 6530 4<sup>th</sup> Street NW**

Ownership Parcel	Description	Uses / Tenants	Condition of Structures	Comments
10	Vacant			Appears to be part of Parcel 8
11	Vacant			Undevelopable strip, access only to Chamisal Lateral
12	Industrial building	Self-storage	Fair to good	Some graffiti that should be cleaned up
13	Retail building	Starlet Dance Studio	Fair	
14	Mobile home park		Poor	Substandard lot layout, unpaved parking and interior roadway, no landscaping
15	Retail building	Vacant	Poor	Peeling paint
16	Church and House	Church	Good	House is occupied.
17	Retail building	1 <sup>st</sup> Payday Loans	Fair	
18	2 Houses		1 Fair to Good 1 Poor	Both houses are occupied.; one has stucco in need of repair, peeling and faded paint on windows and wood addition
19	House		Poor	House is vacant. Windows are boarded up, stucco in need of repair
20	Vacant			Corner lot.

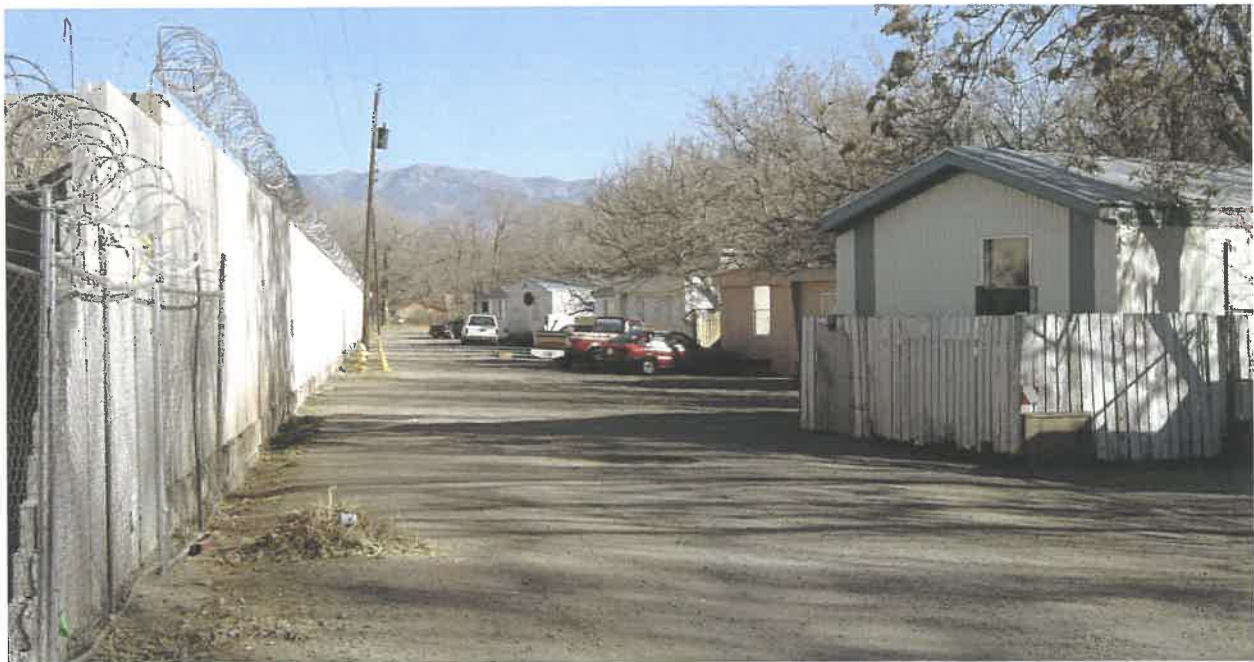
**Property #14. 6518 4<sup>th</sup> Street NW**

There are several deteriorated or deteriorating structures in the study area. These include structures on Parcels 15 and 18. In addition, the condition of the mobile home park on Parcel 14 is poor.

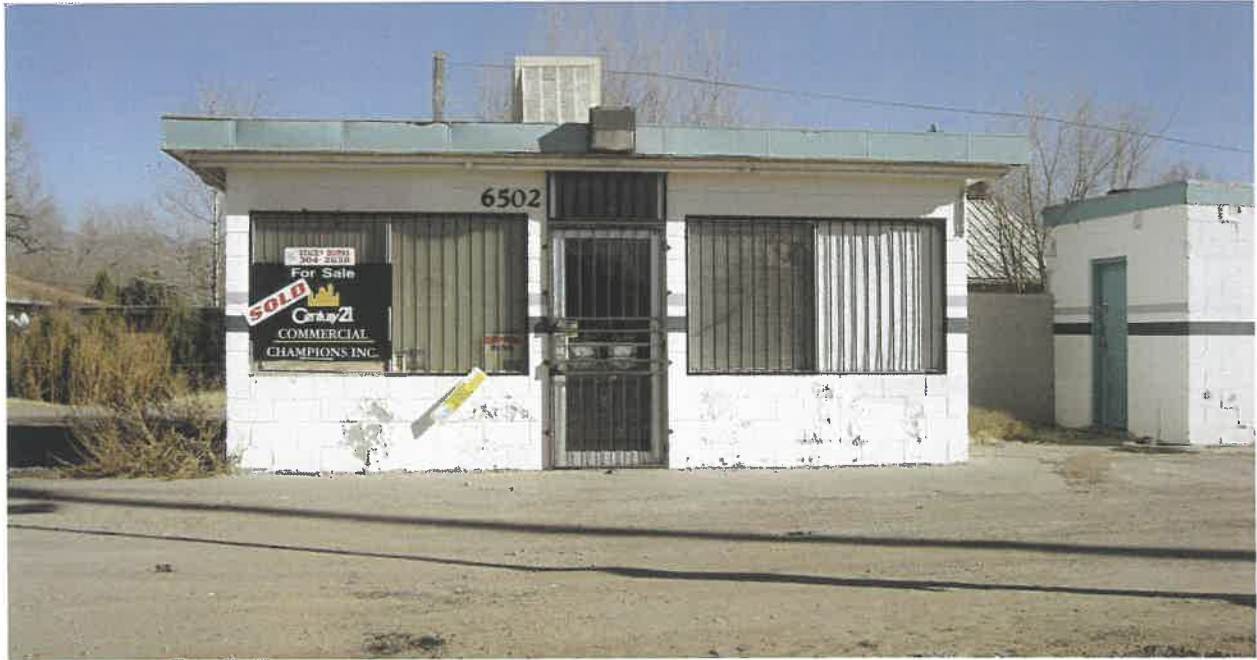
**Property #15. 6502 4<sup>th</sup> Street NW**

Renovation of the retail structure on Parcel 15 has been inhibited because of issues surrounding the title of the property.

Bernalillo County Assessor records as of December 26, 2006 indicate that the most recent property tax payment on Parcel 15 was in 2001. The tax delinquency does not yet exceed the County Assessor's appraised value, which is an indicator of the fair value of the land. The County Assessor does not guarantee accuracy of their on-line records, so further research should be conducted prior to action beyond designation of the study area.
